INVENTORY OF MONUMENTS AT PAGAN

Volume One
Monuments 1-255

PIERRE PICHARD

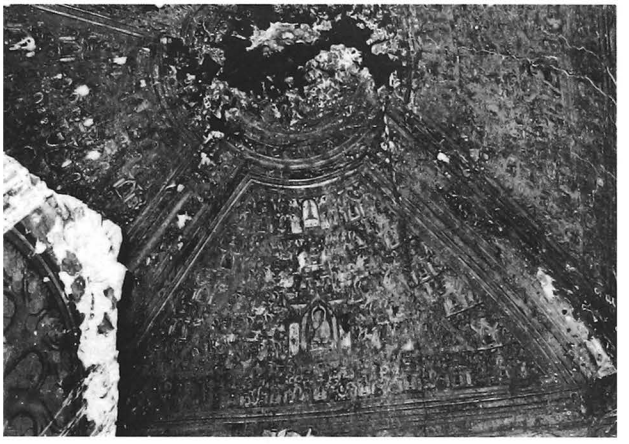
732 g - Shrine vault, from south

6 image
- 1 seated Buddha, facing east (damaged and headless), against a screen wall.

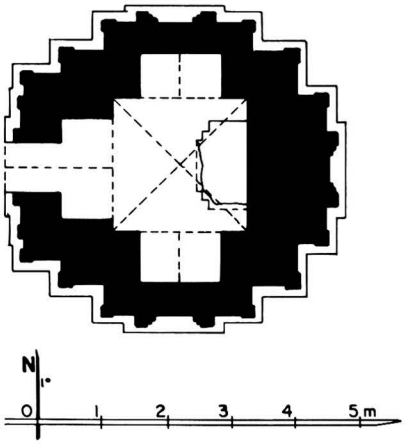
733 a - Plan

5 present condition
- upper parts collapsed.
- repaired 1986.

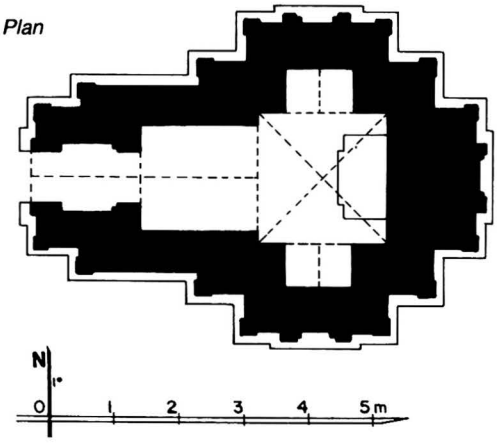
734 a - Plan

5 present condition
- repaired 1980 (Arch. Dept).

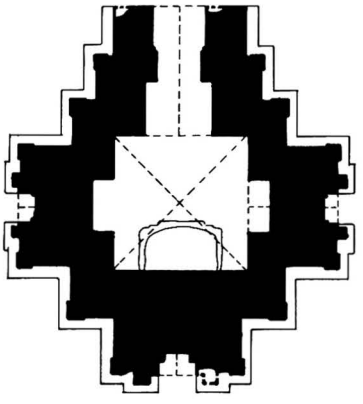
735 a - Plan

5 present condition
- no maintenance.
- porch collapsed.
- upper parts badly damaged.

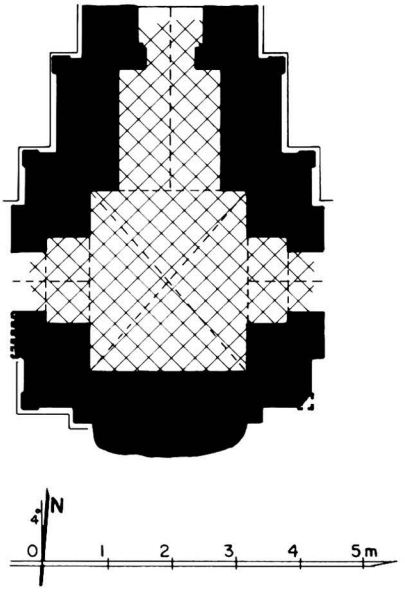
736 a - Plan

5 present condition
- ruined.
- base disintegrated.
- vaults and upper parts collapsed.
- ground floor buried under debris.

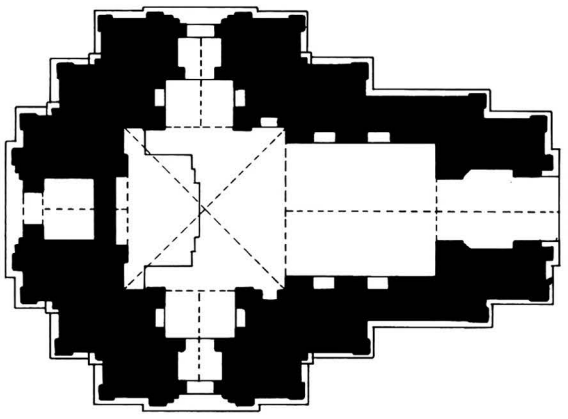
741 a - Plan

5 present condition
- no maintenance.
- base disintegrated.
- east porch collapsed.
- upper parts badly damaged and endangered.

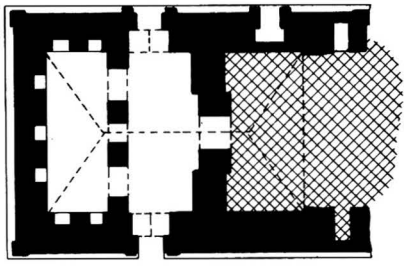
742 a - Plan

5 present condition
- half-ruined.
- east wall and vault over east room collapsed.
- ground floor partly buried under debris.

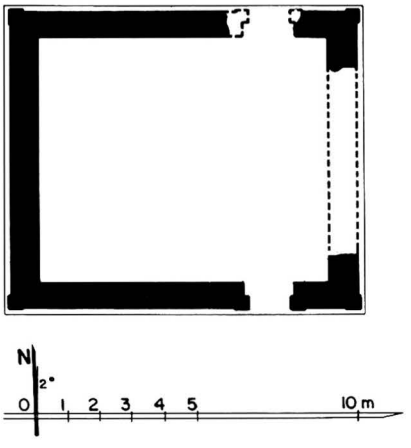
743 a - Plan

5 present condition
- ruined.
- no trace of vaults.
- east wall collapsed.

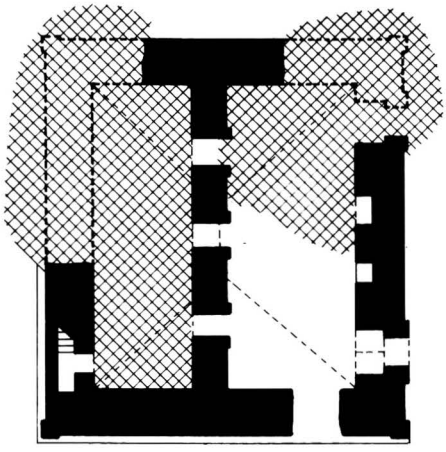
5 present condition
- ruined.
- vaults collapsed.
- ground floor buried under debris.
- structure badly cracked.

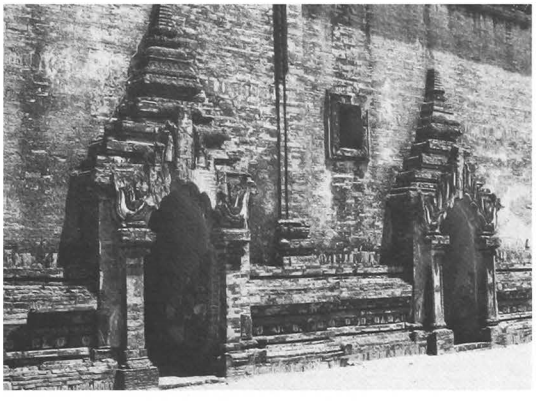
5 present condition
- regularly maintained.
- repaired 1920-23 and (Const. Corp.) 1977-79.
- top of tower destroyed.

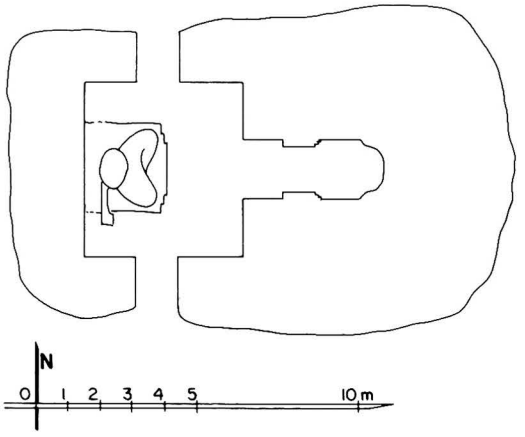
749 a - Plan

5 present condition
- ruined.
- base of walls only remains.

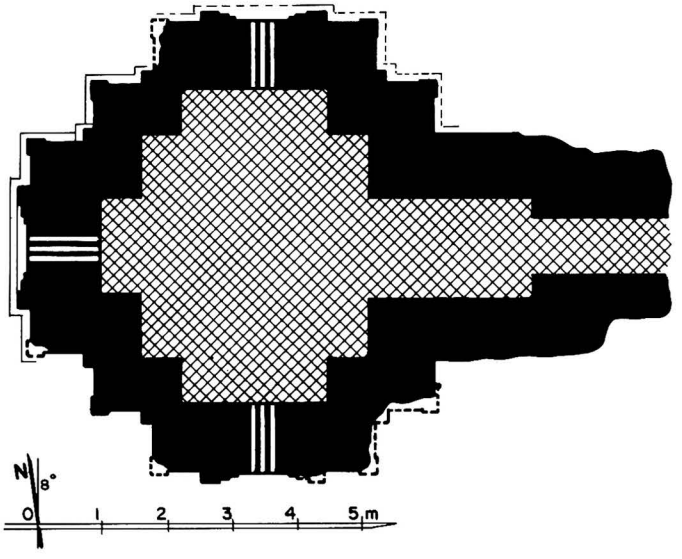
751 a - Plan

5 present condition
- ruined.
- vaults and upper parts collapsed.
- ground floor buried under debris.

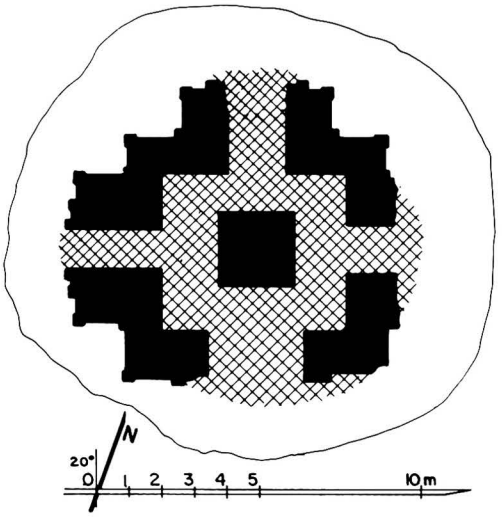
752 a - Plan

5 present condition
- ruined.
- vaults and upper parts collapsed.
- ground floor buried under debris.

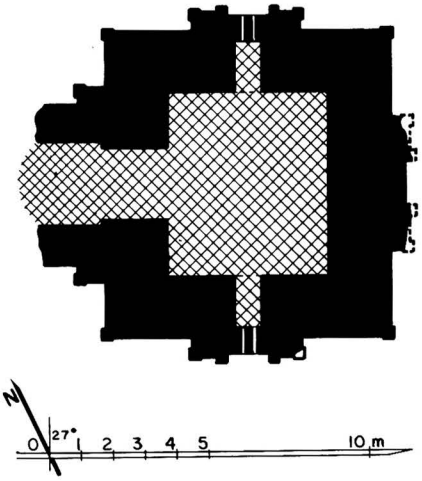
753 a - Plan

5 present condition
- ruined.
- vaults and upper parts collapsed.
- ground floor buried under debris.

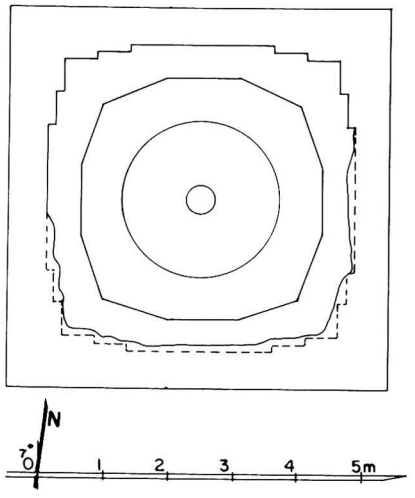
754 a - Plan

5 present condition
- no maintenance.
- base disintegrated.
- upper parts damaged.

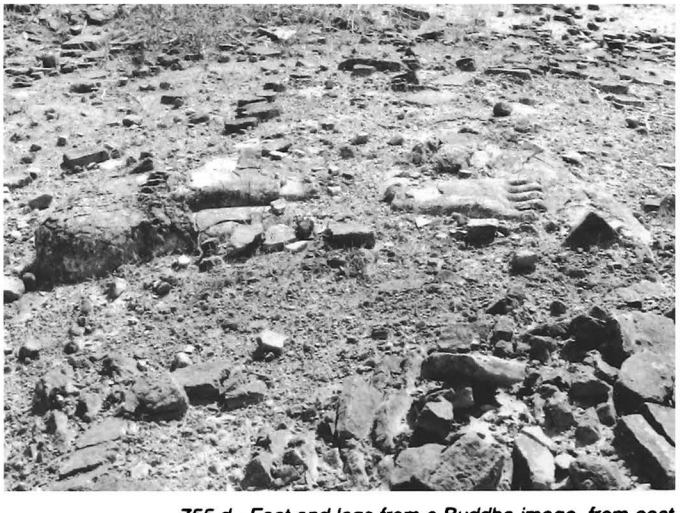
5 present condition
- brick debris.
- legs from a Buddha image.
- height: approx. 1.60 m.

755 d - Feet and legs from a Buddha image, from east

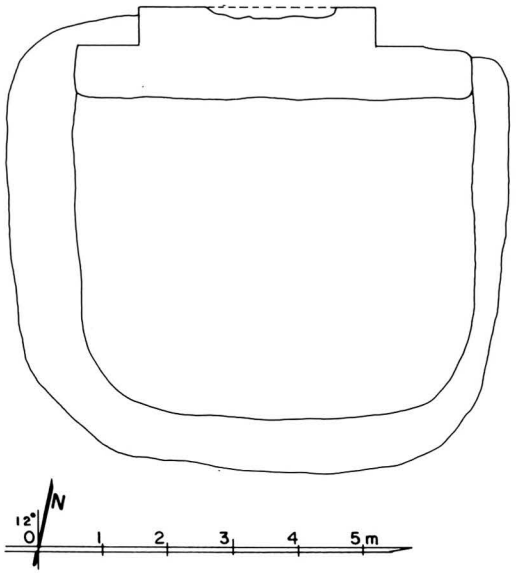
758 a - Plan

5 present condition
- brick and stone debris.
- only part of a north wall remaining.
- height: approx. 1.30 m.

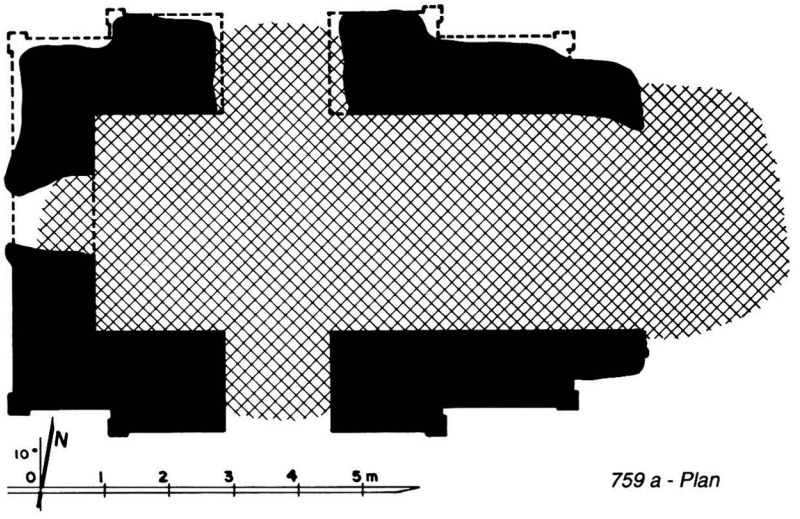
759 a - Plan

5 present condition
- ruined.
- vaults and upper parts collapsed.
- ground floor buried under debris.

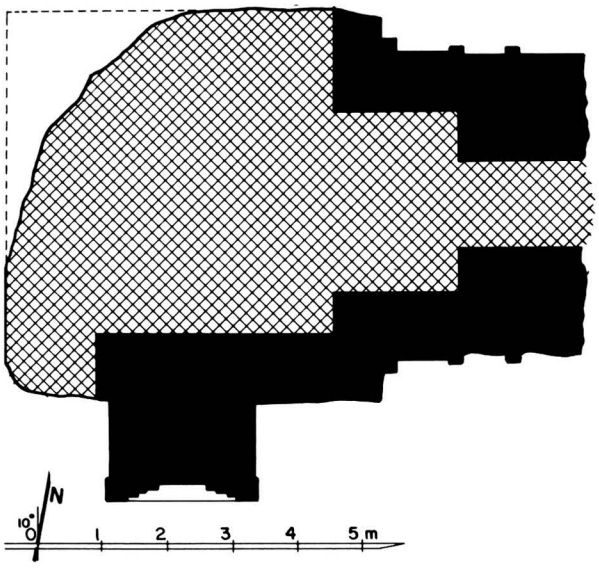
760 a - Plan

5 present condition
- ruined.
- vaults and upper parts collapsed.
- only parts of east and south faces remain.
- ground floor buried under debris.

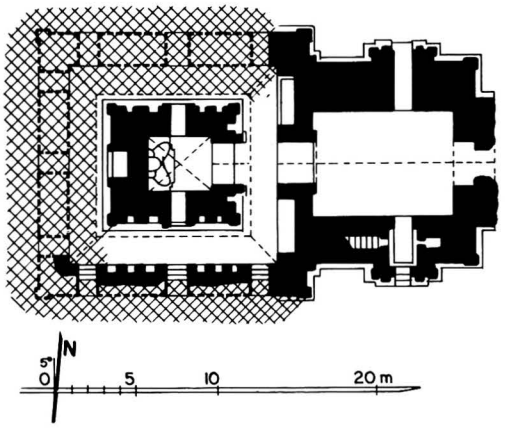
761 a - Plan

5 present condition
- ruined.
- vaults and upper parts collapsed.
- ground floor partly buried under debris.

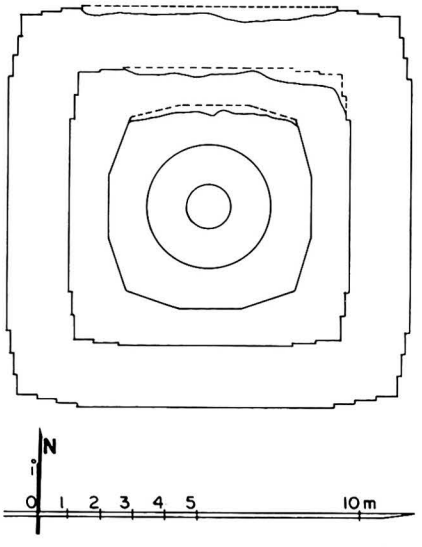
762 a - Plan

5 present condition
- no maintenance.
- base and terraces disintegrated.
- upper parts badly damaged.

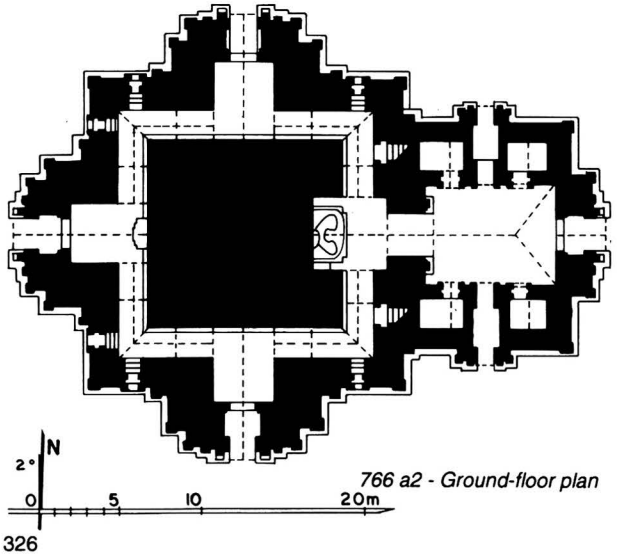
766 a2 - Ground-floor plan

5 present condition
- regularly maintained.
- parts of upper storey collapsed with upper parts during the 1975 earthquake.
- restored (Const. Corp.) 1979-80.

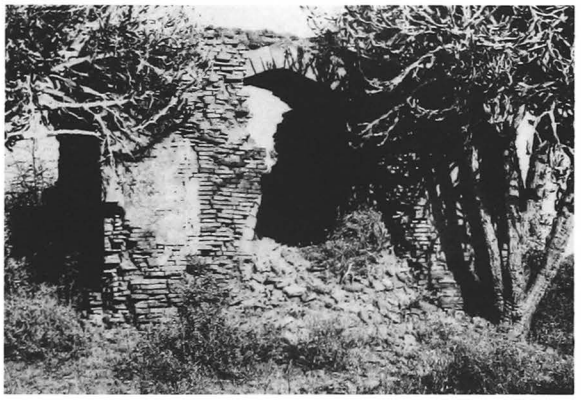
5 present condition
- ruined.
- shrine collapsed.
- ground floor buried under debris.

769 c - From south-east

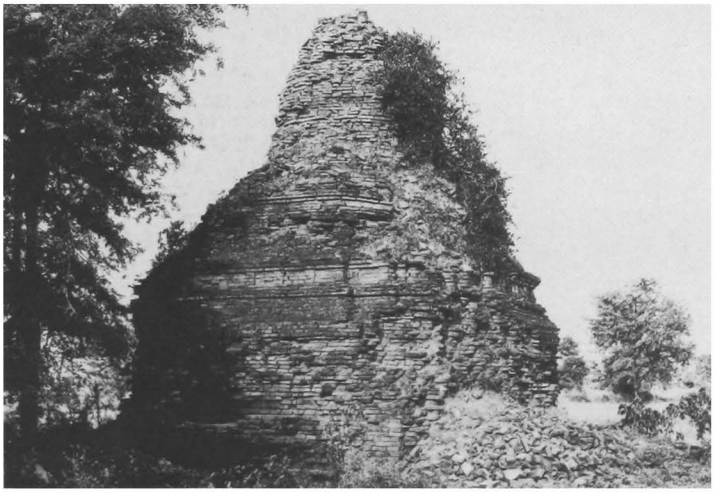
774 b - From south-west

5 present condition
- half-ruined.
- base and terraces disintegrated.
- upper parts badly damaged.

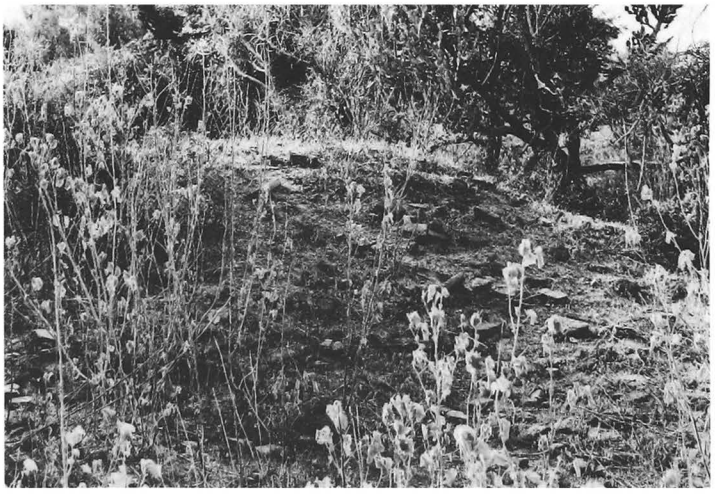
775 b - From south

5 present condition
- brick debris.
- height: approx. 1.00 m.

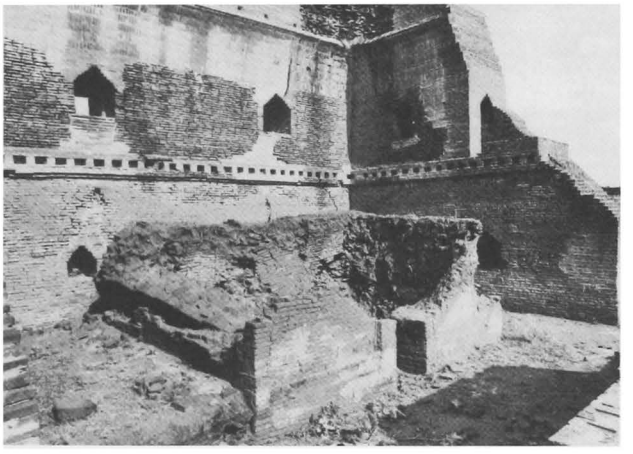
776 c - Interior, central cell from south-east, 1993

5 present condition
- ruined.
- east part, vaults and roof collapsed.
- cleared and repaired (Dept.) 1990-91.

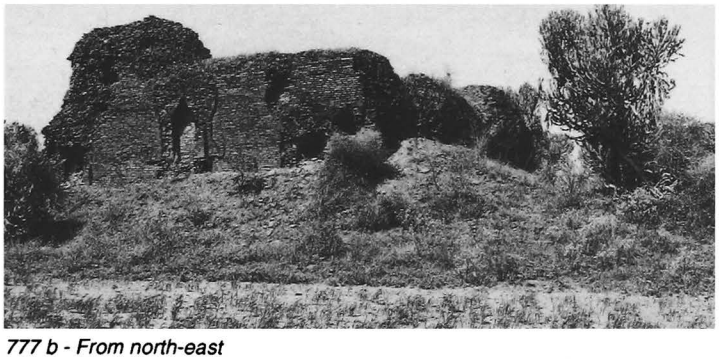
777 b - From north-east

5 present condition
- ruined.
- no more trace of vaults.
- ground floor buried under debris.

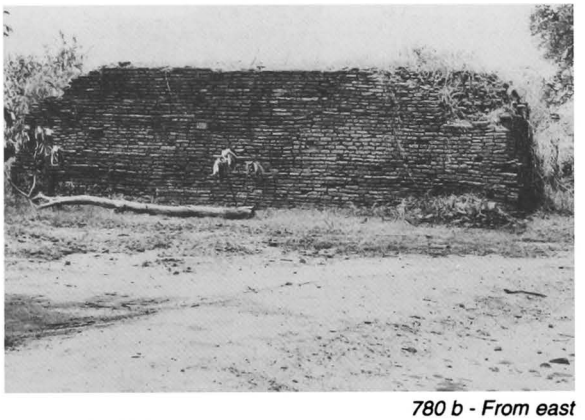
780 b - From east

5 present condition
- height: approx. 2.10 m.

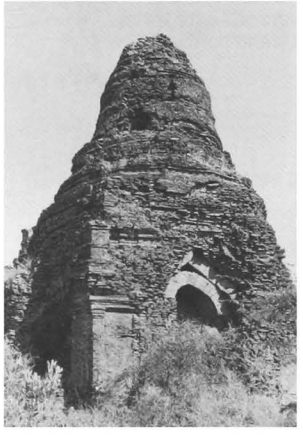
781 d - From south-west, 1982

5 present condition
- porches collapsed.
- repaired (Dept.) 1984.

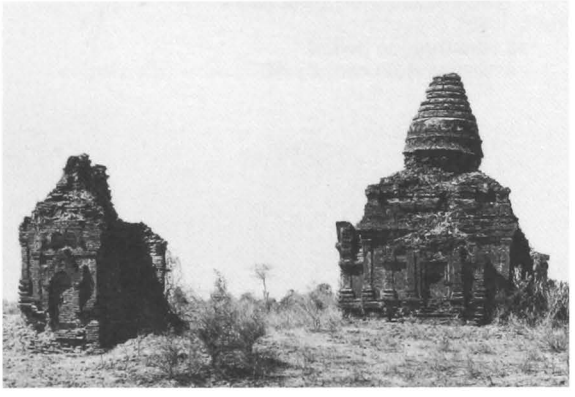
786 b - From south, 1983, together with 790

5 present condition
- restored (Dept.) 1984.

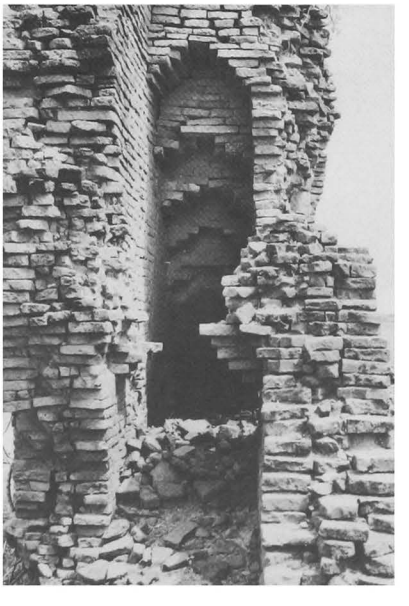
788 d - West wall, internal stair case, from south

5 present condition
- ruined.
- vaults collapsed.
- only parts of west and east walls remain.
- ground floor buried under debris.

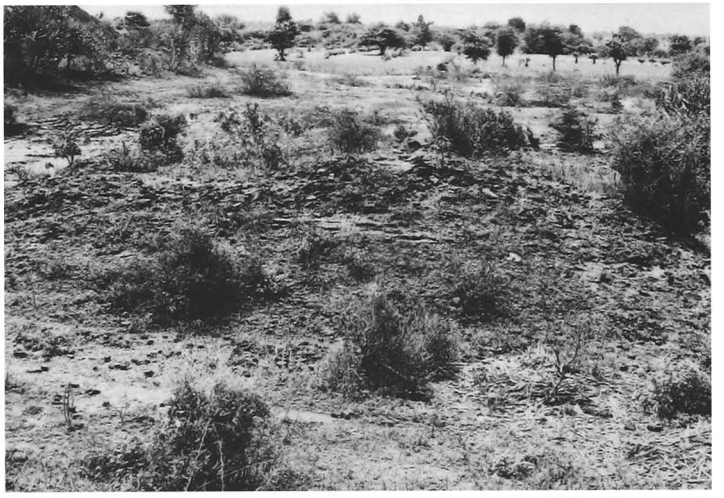
789 b - From north

5 present condition
- brick debris.
- height: approx. 1.20 m.

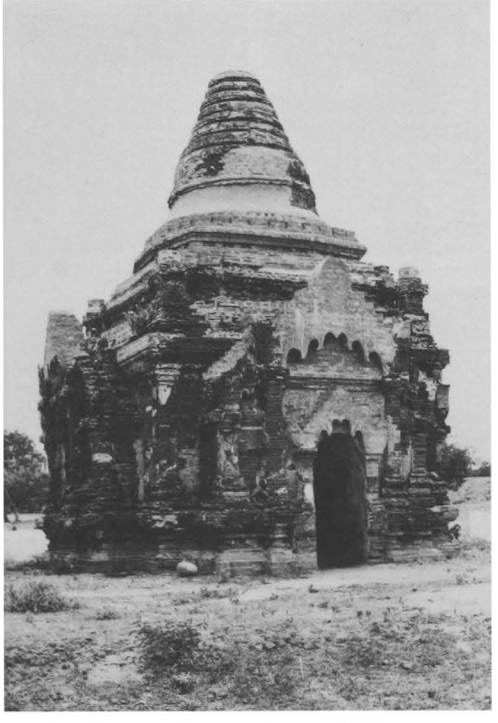
790 b - West face, from north-west, 1985

5 present condition
- repaired (Dept.) 1985.
- maintained by Trustees.
- whitewashed 1989.

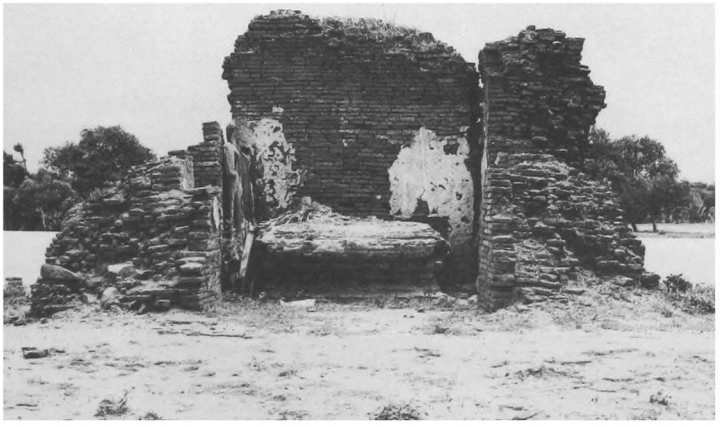
792 c - From west

5 present condition
- ruined.
- vaults and upper parts collapsed.

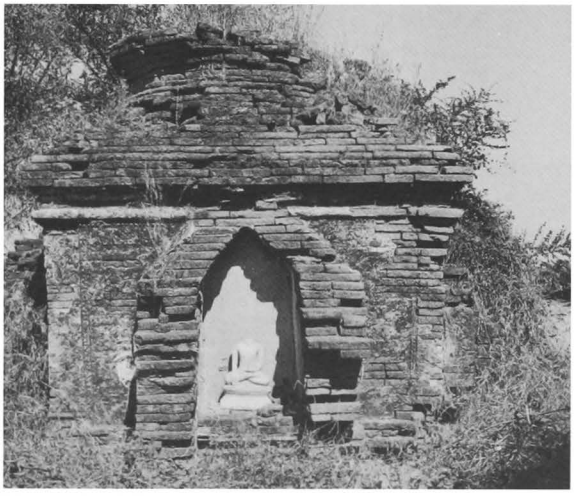
794 b - South face

5 present condition
- no maintenance.
- upper parts nearly destroyed.

7 decoration
- plain stucco mouldings, still in place: 15%.

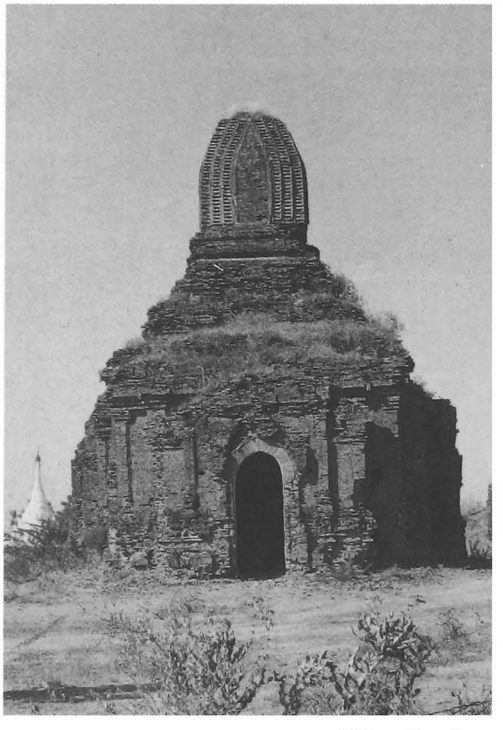
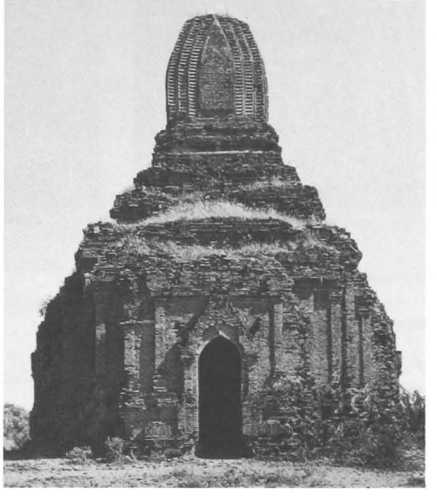
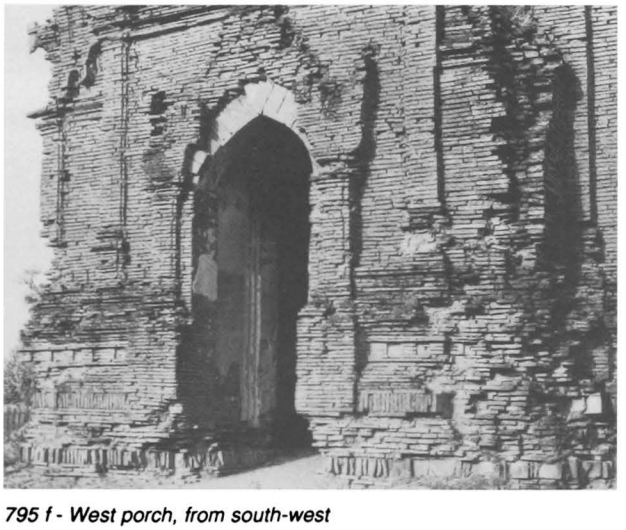
5 present condition
- base disintegrated.
- terraces badly damaged.
- partially repaired (Const. Corp.) 1992.

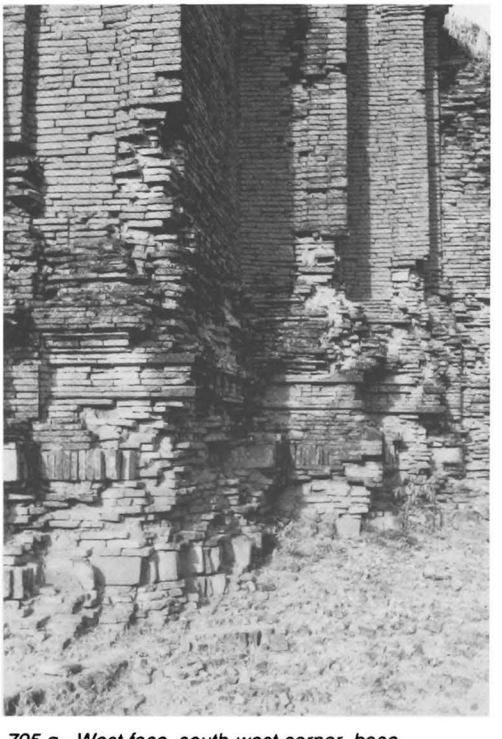
795 g - West face, south-west corner, base

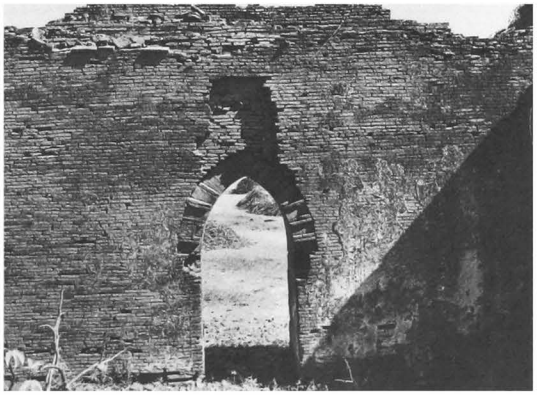
5 present condition
- ruined.
- no more trace of vaults.
- ground floor partly buried under debris.

796 d - East wall, inner face, from west

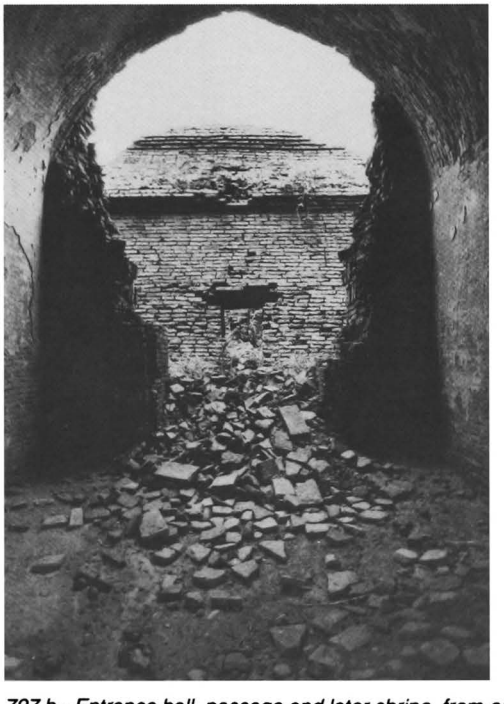
5 present condition
- half-ruined.
- west part collapsed.
- vaults and upper parts collapsed.
- ground floor partly buried under debris.
- shrine destroyed, later structure built in its place with re-used bricks.

797 h - Entrance hall, passage and later shrine, from east

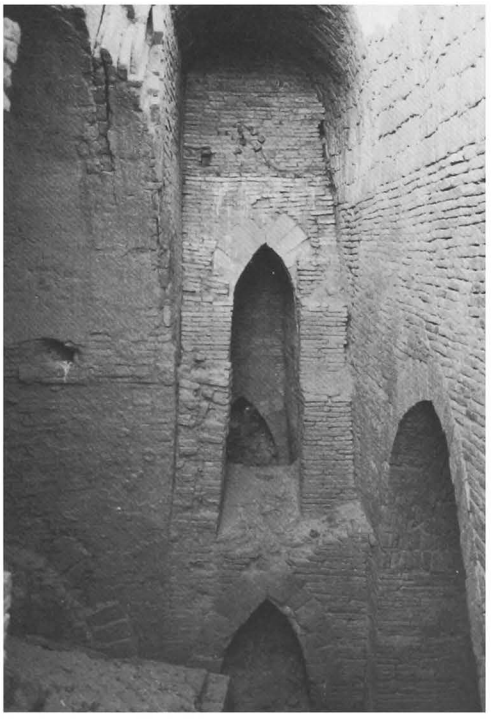
801 h - East corridor, blocked by later additions, from south

5 present condition
- half-ruined.
- west part collapsed.
- upper parts collapsed.
- ground floor partly buried under debris.

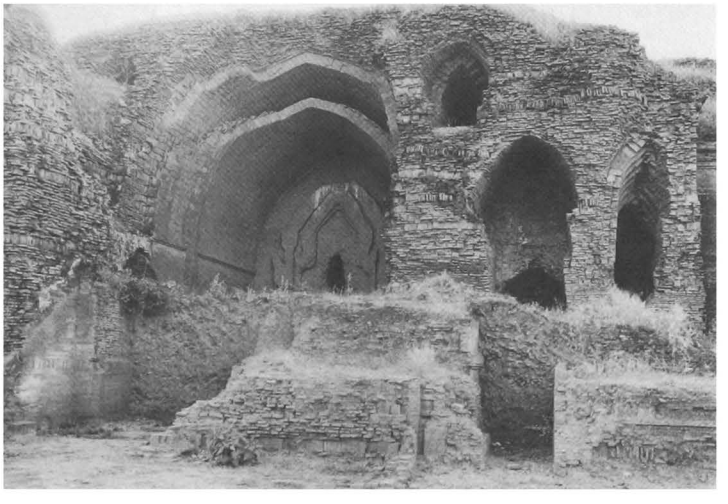
5 present condition
- base disintegrated.
- east face partly collapsed.
- porch vaults disintegrated.
- ground floor of east forepart buried under debris.
- repaired (Const. Corp.) 1985-93.

803 i - East face, west forepart, 1986, after clearing

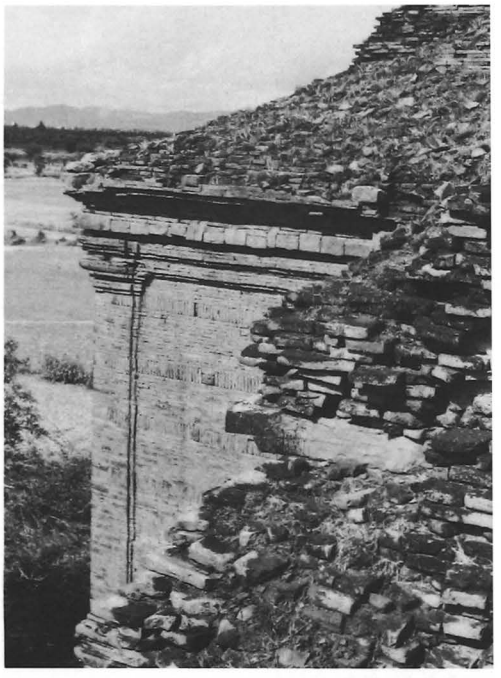
803 j - East face, south-east corner, detail of stone headers under cornice, from north-east

7 decoration
exterior and interior:
- stucco work not implemented, brickwork prepared to receive it.

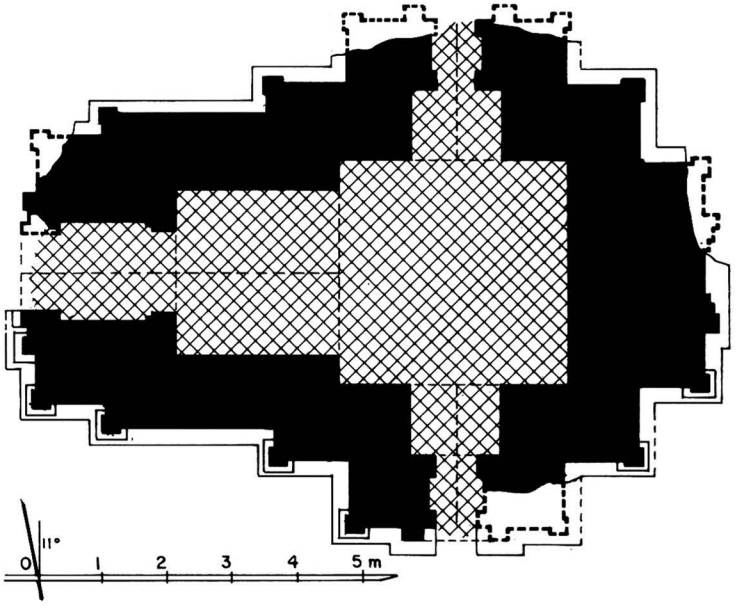
806 a - Plan

5 present condition
- ruined.
- vaults and upper parts collapsed.
- ground floor buried under debris.

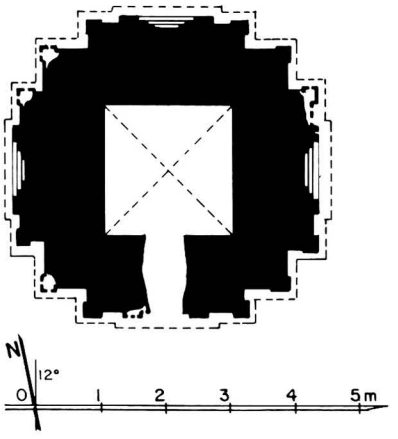
807 a - Plan

5 present condition
- half-ruined.
- base disintegrated.
- terraces and upper parts collapsed.
- opening made by looters in south face.

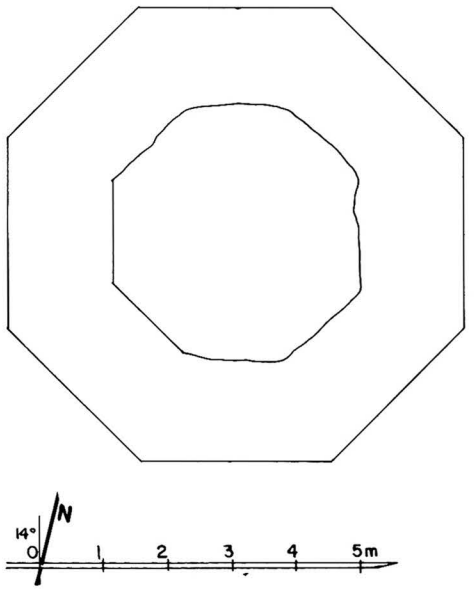
808 a - Plan

5 present condition
- 4 brick courses in place.
- height: approx. 0.40 m.

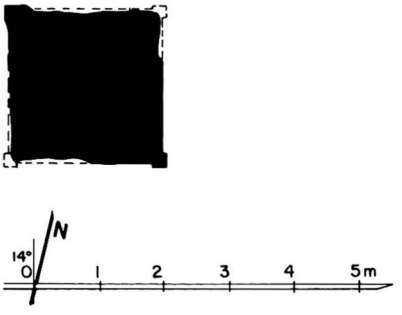
809 a - Plan

5 present condition
- half-ruined.
- base and terraces disintegrated.
- upper parts destroyed.
- leaning southwards.

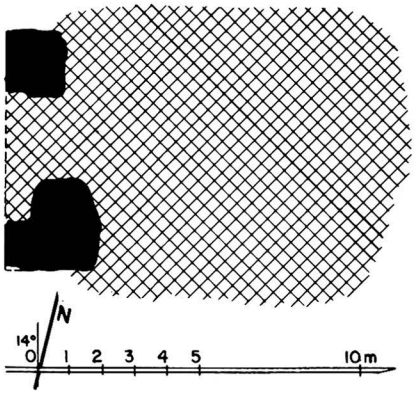
810 a - Plan

5 present condition
- totally ruined.
- only two corners remain on west side.
- ground floor buried under debris.

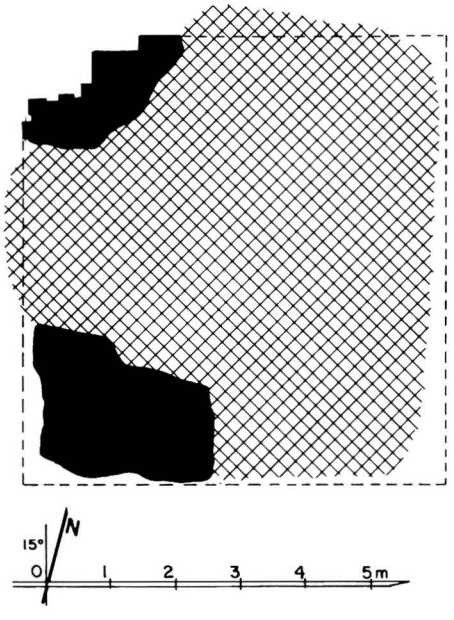
811 a - Plan

5 present condition
- ruined.
- only two corners remain on west side.
- ground floor buried under debris.

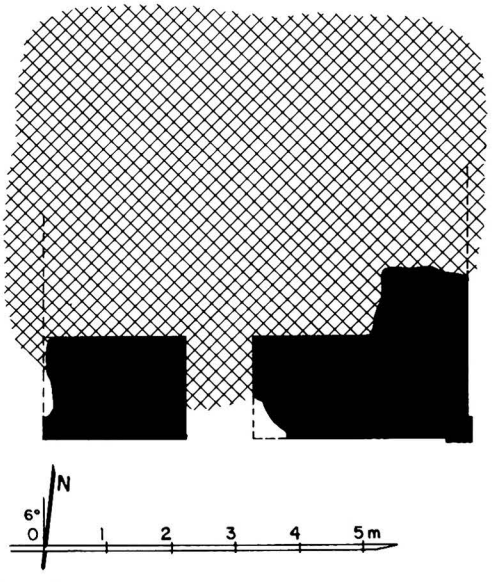
812 a - Plan

5 present condition
- ruined.
- only parts of south wall remain.
- ground floor buried under debris.

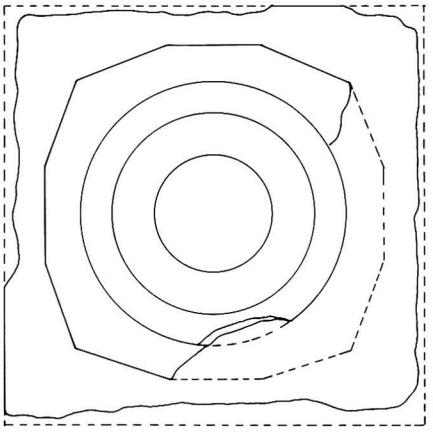
813 a - Plan

5 present condition
- no maintenance.
- base and terraces disintegrated.
- upper parts damaged.

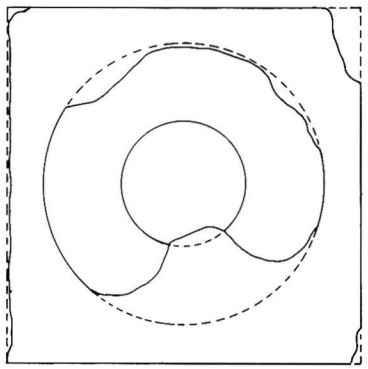
814 a - Plan

5 present condition
- no maintenance.
- base and terraces disintegrated.
- upper parts badly damaged.

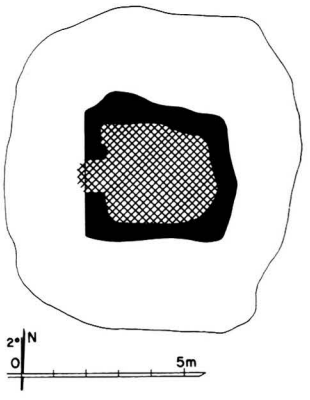
816 a - Plan

5 present condition
- ruined.
- vaults collapsed.
- ground floor buried under debris.

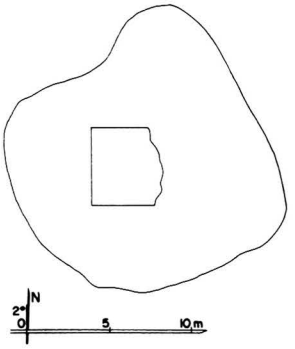
817 a - Plan

5 present condition
- base of a square structure.
- height: approx. 0.70 m.

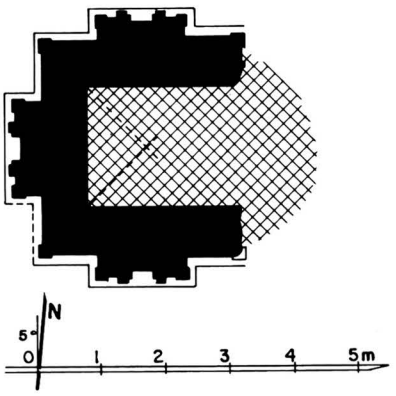
818 a - Plan

5 present condition
- ruined.
- east porch collapsed.
- vaults and upper parts collapsed.
- ground floor buried under debris.

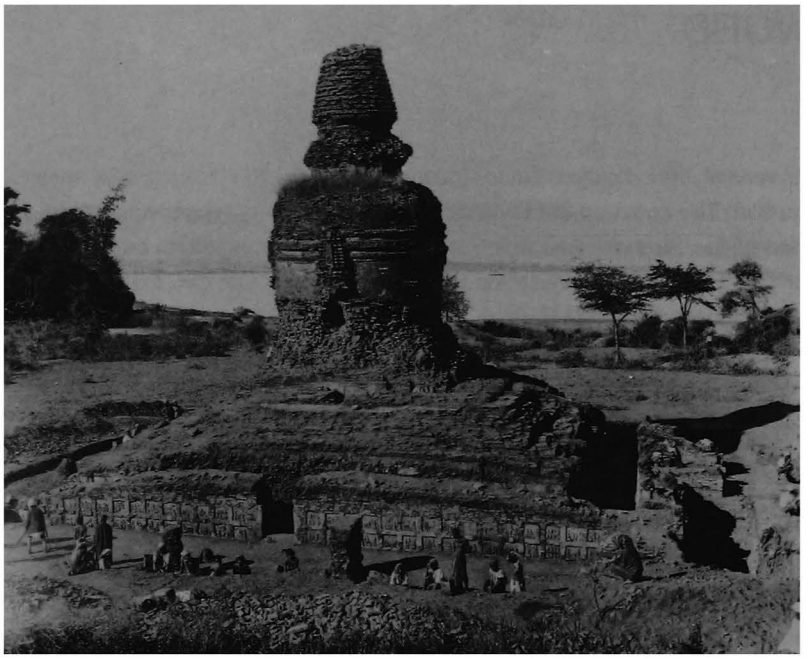
***1031** West Hpet-leik, from east, during clearance of debris in 1905 (phot. ASI, New Delhi)*

***1031** West Hpet-leik, same view in 1986, with the reinforced concrete roof erected in 1908*

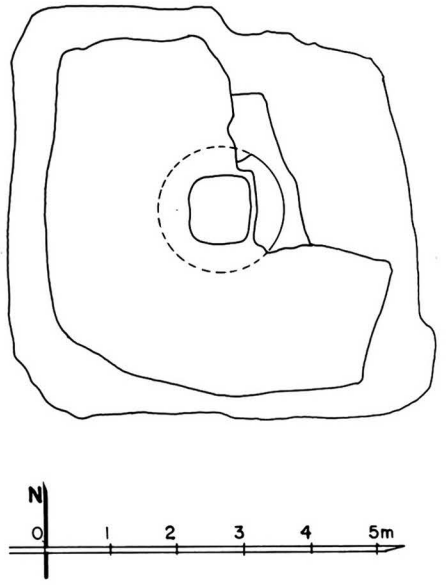
819 a - Plan

5 present condition
- ruined.
- base buried under debris.

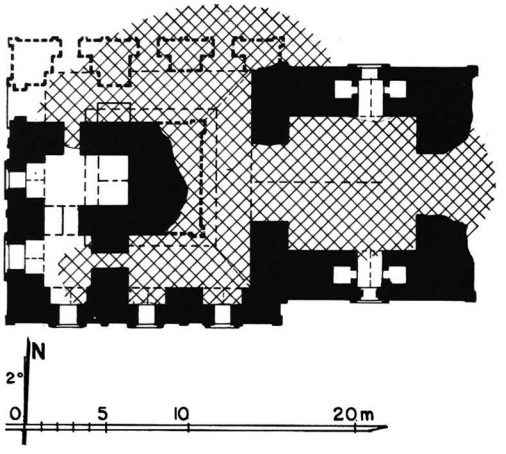
820 a1 - Plan

5 present condition
- no maintenance.
- half-ruined.
- vaults and upper parts collapsed.
- ground floor buried under debris.

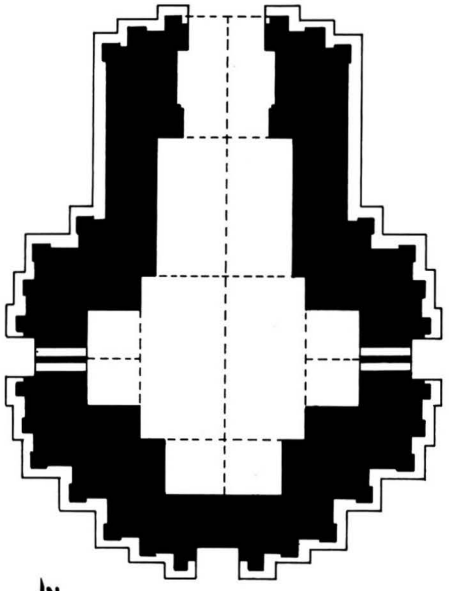
821 a - Plan

5 present condition
- no maintenance.
- vaults and upper parts collapsed.
- base disintegrating.

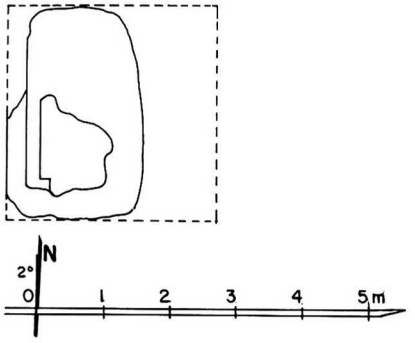
822 a - Plan

5 present condition
- ruined.
- base and terraces disintegrated.
- only part of west face remains.

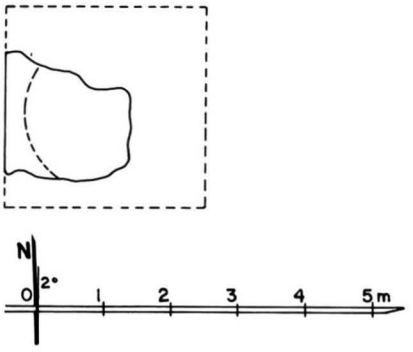
823 a - Plan

5 present condition
- ruined.
- base and terraces disintegrated.
- only part of west face remains.

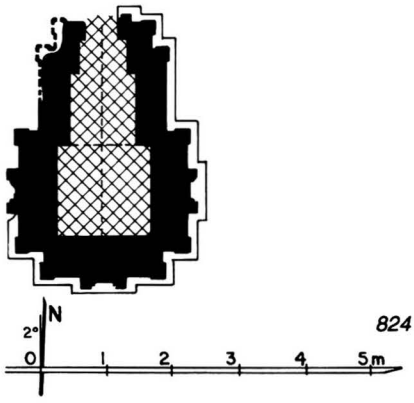
824 a - Plan

5 present condition
- ruined.
- vaults and upper parts collapsed.
- ground floor buried under debris.

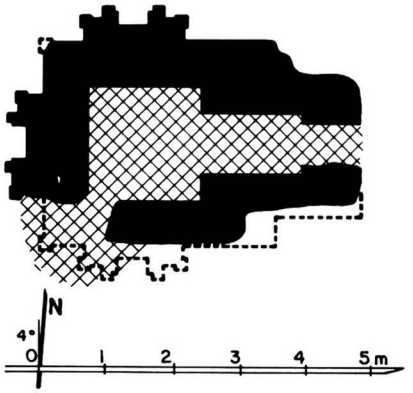
825 a - Plan

5 present condition
- ruined.
- vaults and upper parts collapsed.
- ground floor buried under debris.

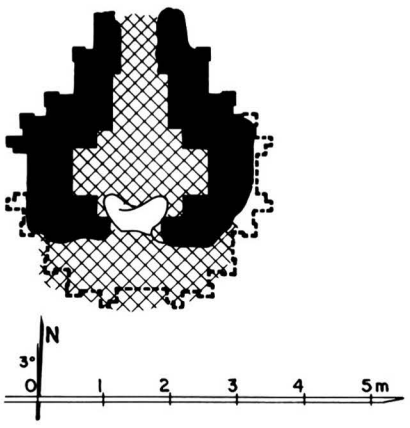
827 a - Plan

5 present condition
- ruined.
- no more trace of vaults.
- ground floor buried under debris.

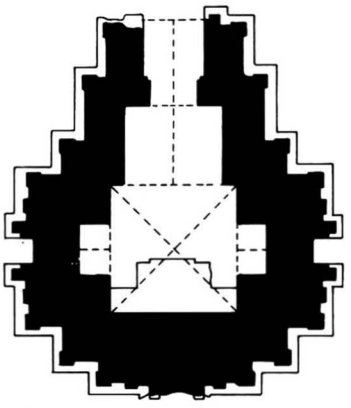
828 a - Plan

5 present condition
- no maintenance and endangered.
- base disintegrated.
- terraces and upper parts badly damaged.

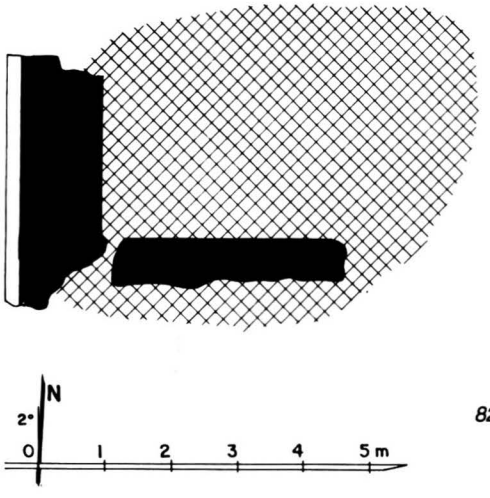
829 a - Plan

5 present condition
- ruined.
- vaults and roof collapsed.
- ground floor buried under debris.

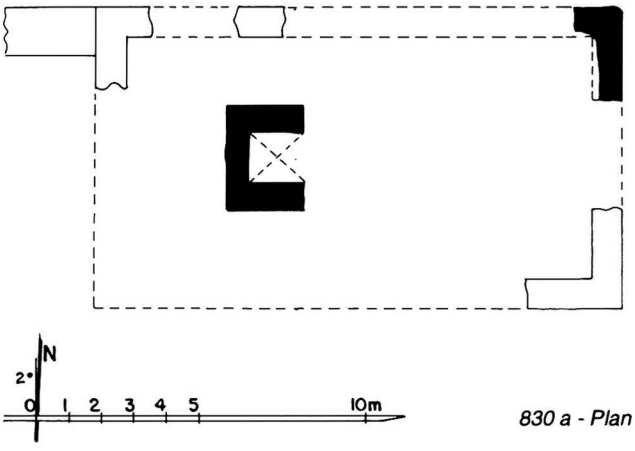
830 a - Plan

5 present condition
- ruined.
- only parts of central cell and north-east corner remain.

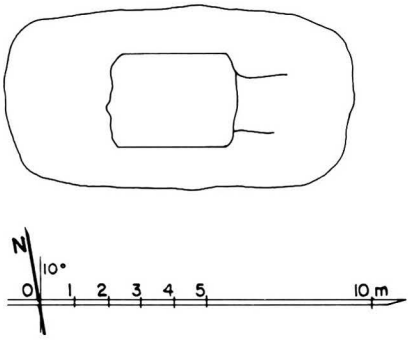
831 a - Plan

5 present condition
- ruined.
- only base of walls remains.

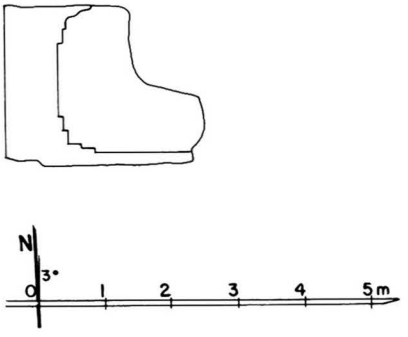
832 a - Plan

5 present condition
- ruined.
- terraces and upper parts collapsed.

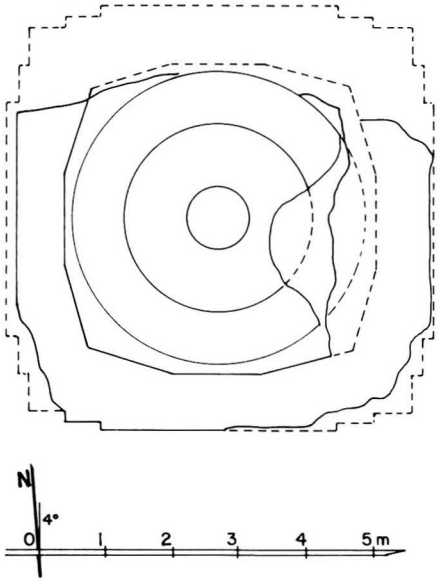
833 a - Plan

5 present condition
- no maintenance.
- base and terraces disintegrated.
- upper parts damaged.

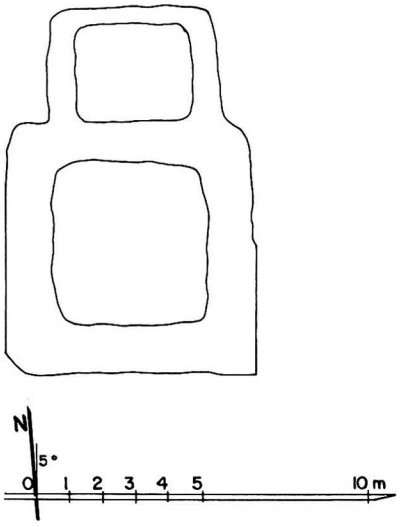
834 a - Plan

5 present condition
- brick debris.
- height: approx. 1.50 m.

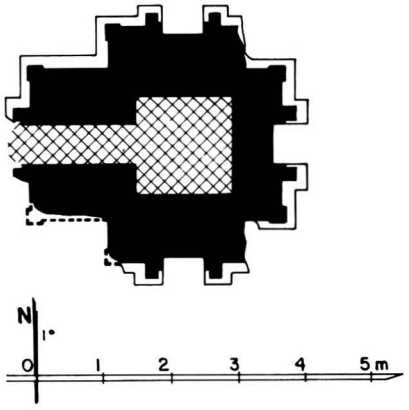
835 a - Plan

5 present condition
- ruined.
- vaults and upper parts collapsed.
- ground floor buried under debris.

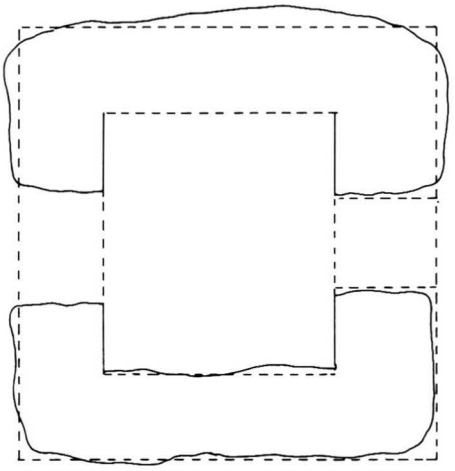
836 a - Plan

5 present condition
- ruined.
- only base of walls remains.
- height: approx. 1.30 m.

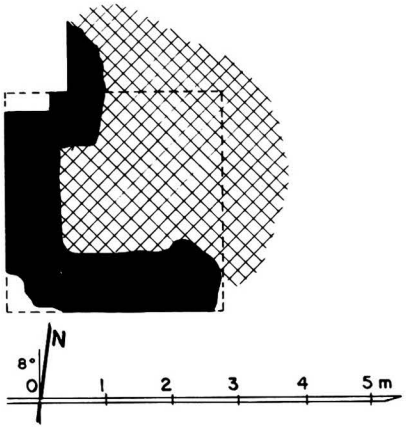
838 a - Plan

5 present condition
- ruined.
- only base of west and south walls remains.
- ground floor buried under debris.

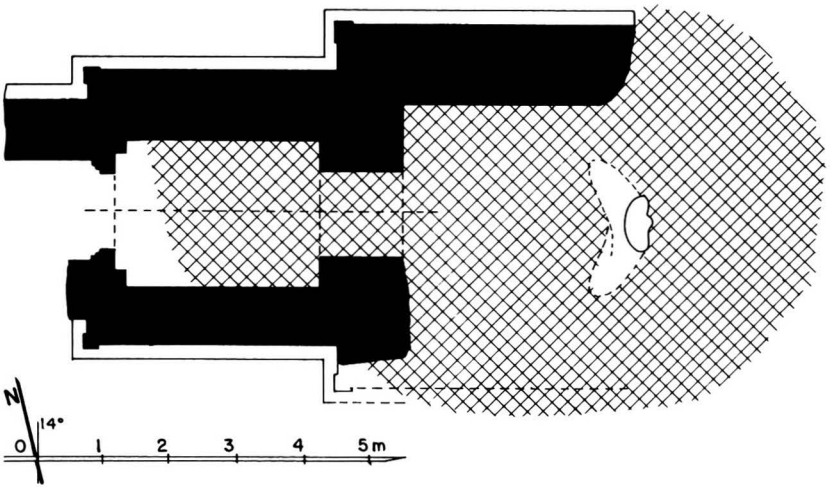
839 a - Plan

5 present condition
- ruined.
- base disintegrated.
- walls of shrine, vaults and upper parts collapsed.
- ground floor buried under debris.

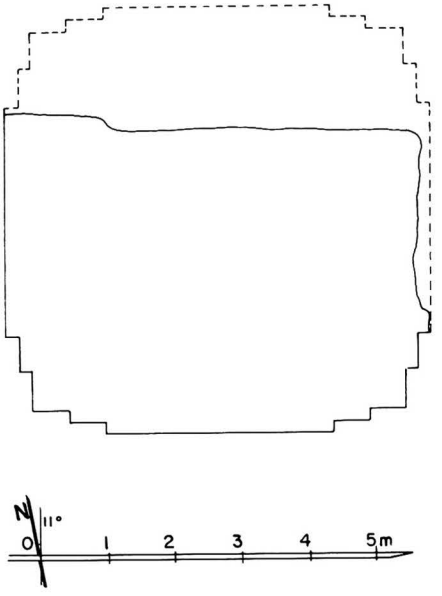
840 a - Plan

5 present condition
- ruined.
- only part of base remains.

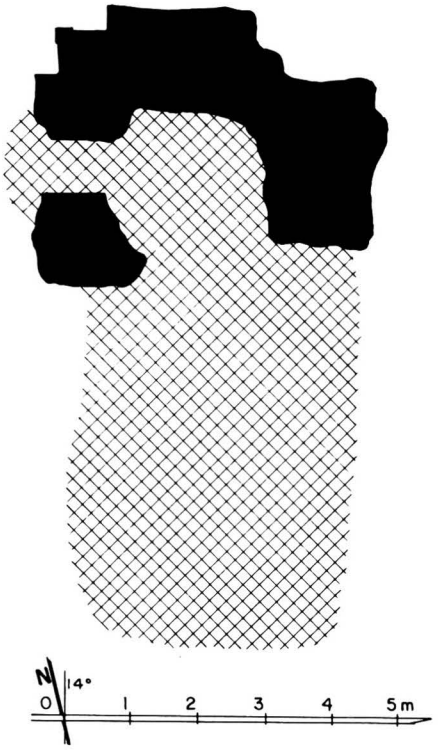
841 a - Plan

5 present condition
- ruined.
- ground floor buried under debris.

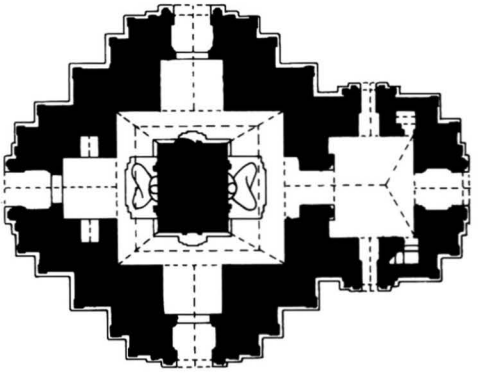
842 a - Plan

5 present condition
- repaired (Const. Corp.) 1985-86.

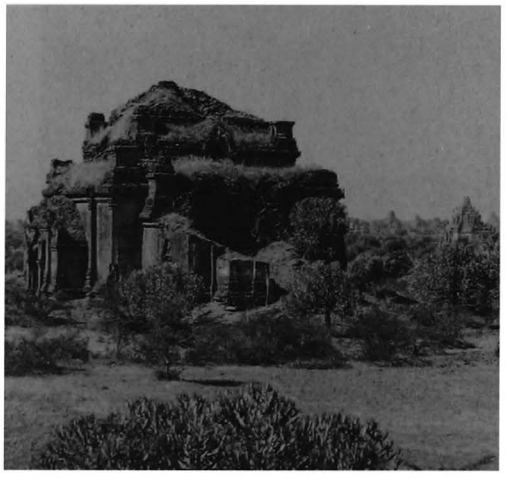
5 present condition
- repaired (Const. Corp.) 1986-88.
- vault over entrance hall collapsed.

843 b - From south-east, 1986

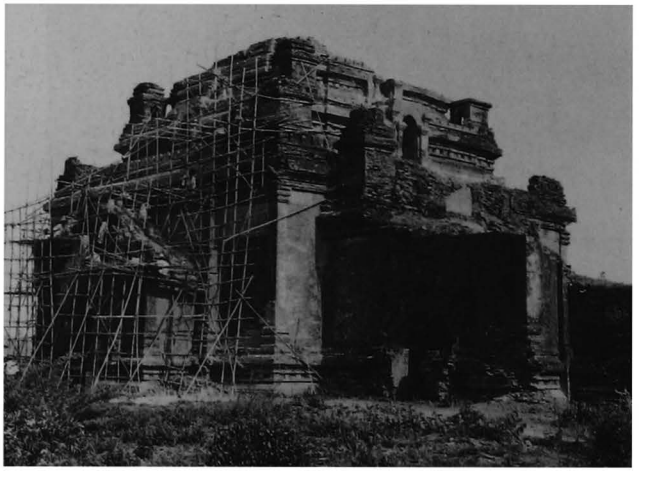
843 c - From south-east, 1988
